Sugar Cove Berm Maintenance Plan

Sugar Cove, Sprecklesville, Maui, Hawaii

October 2014

Sea Engineering, Inc.
Makai Research Pier
Waimanalo, HI 96795

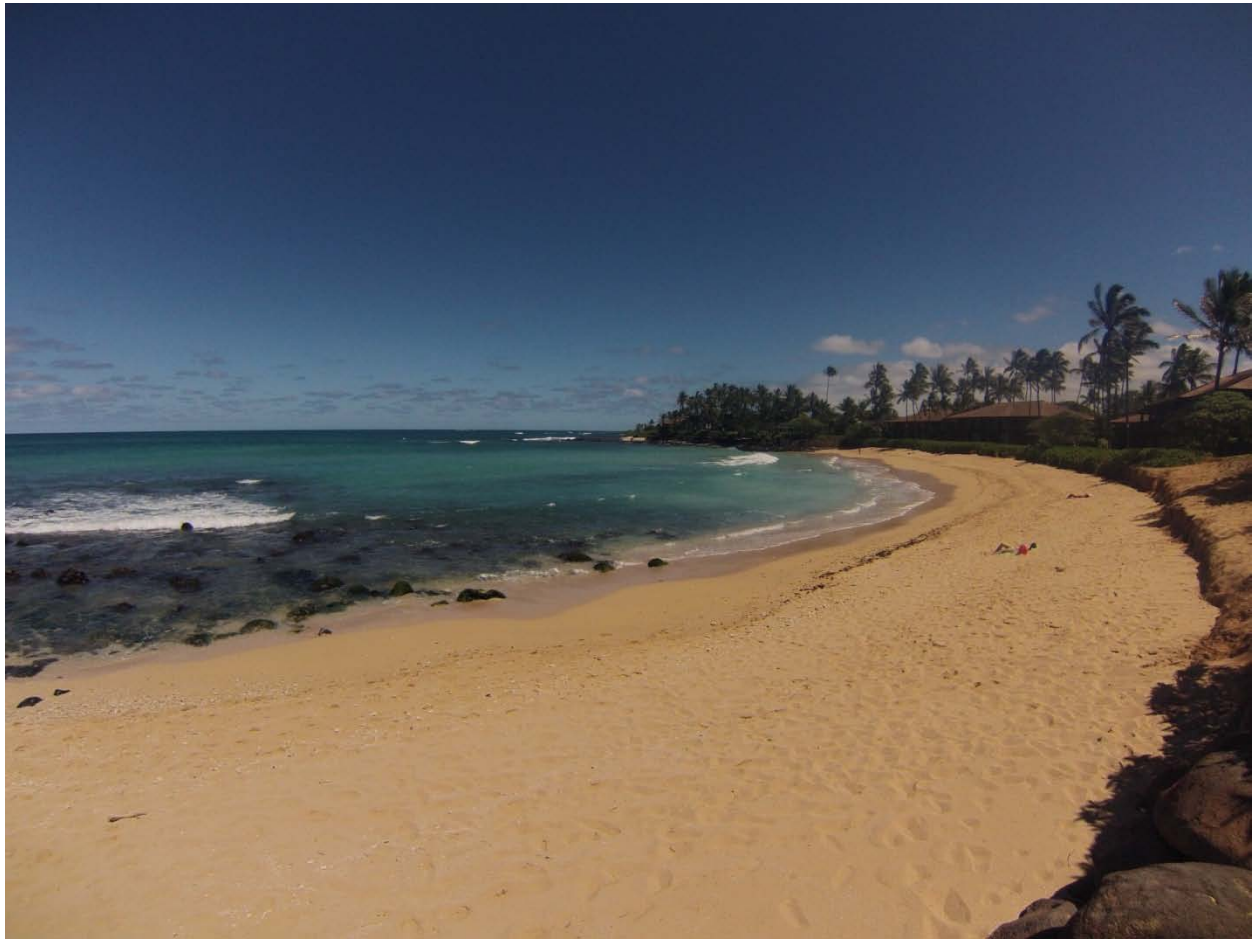
Figure 1-6 Looking east along the restored beach, from near the western boundary

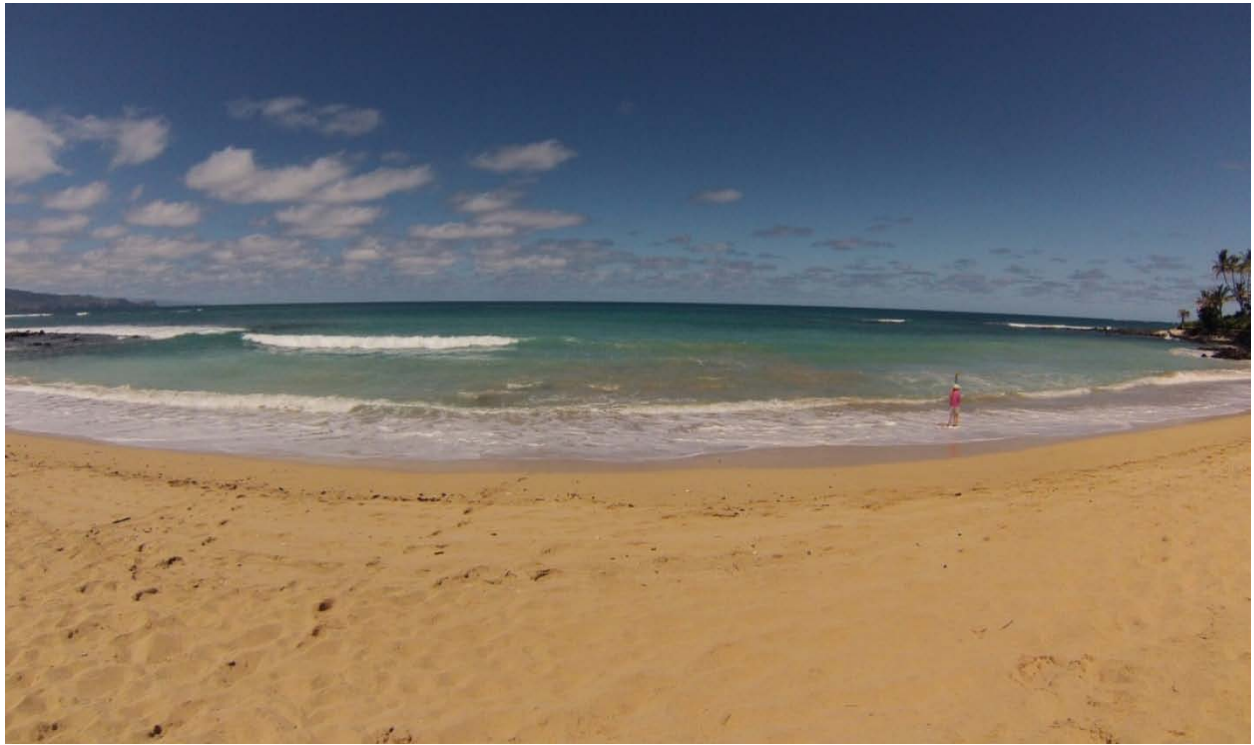
Figure 1-7 Looking offshore across the restored beach, from near the middle of the property

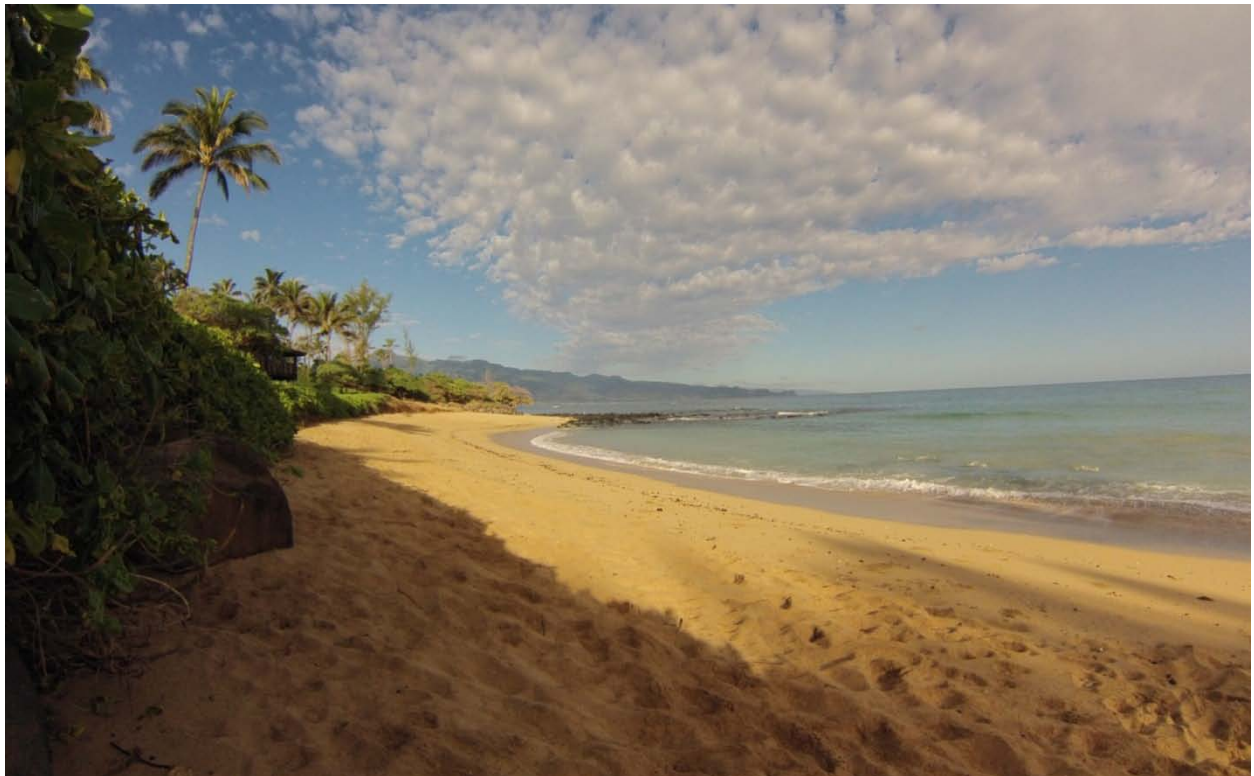
Figure 1-8 Looking west along the restored beach, from near the eastern boundary

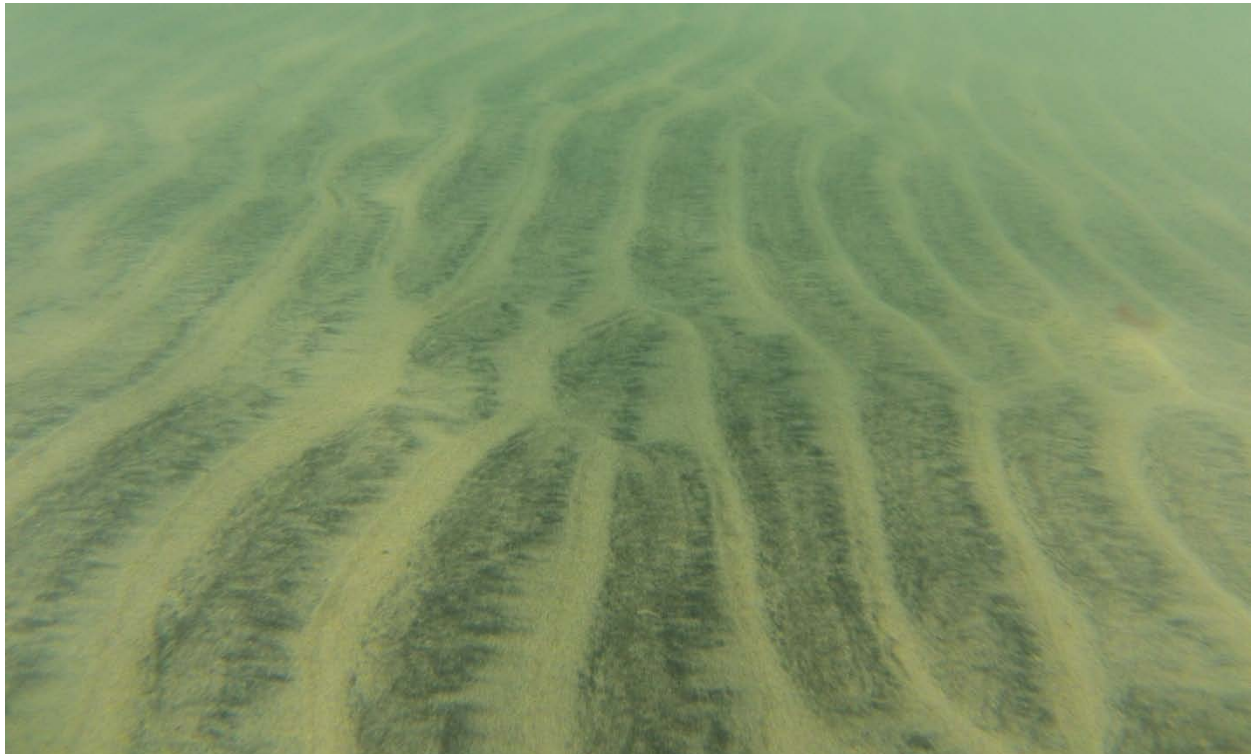
Figure 1-10 Sand ripples forming in the sand field and bar in the nearshore waters of the cove

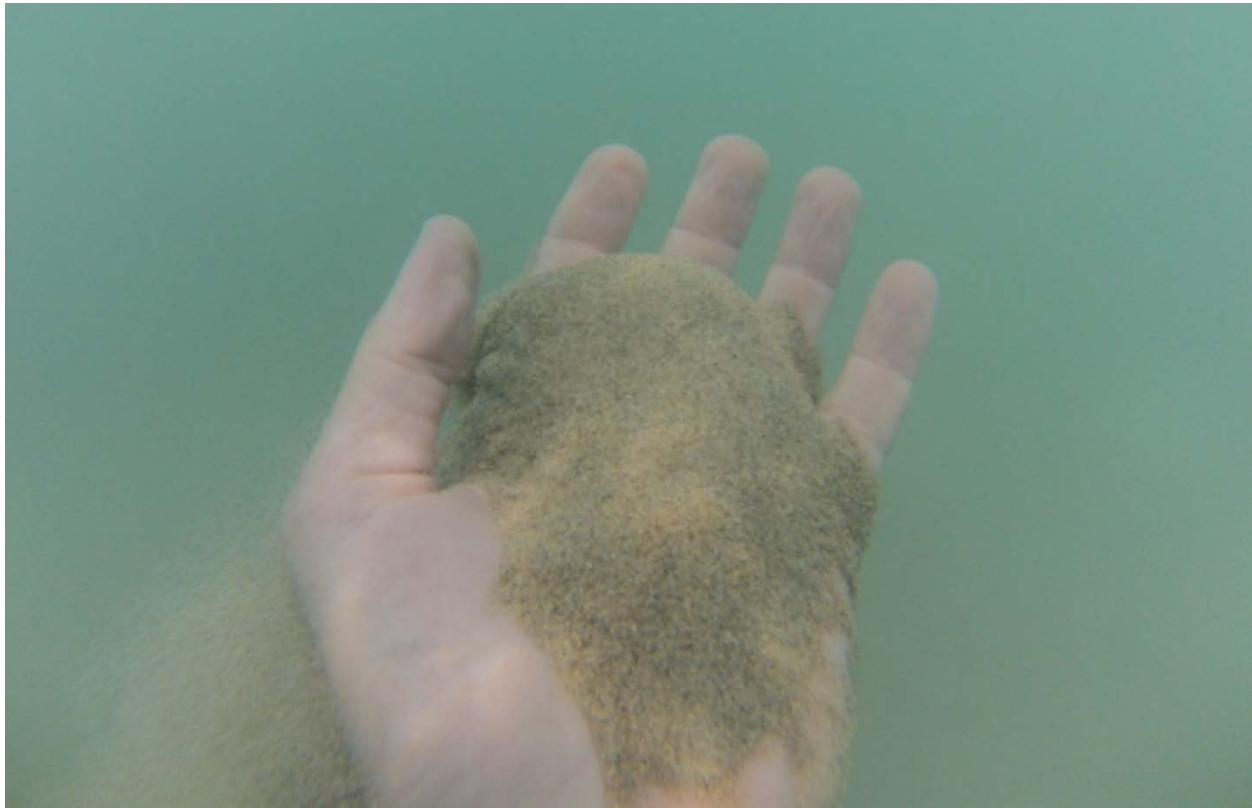
Figure 1-11 Nearshore sand from the sand bar is beach quality material similar to the restored beach sand

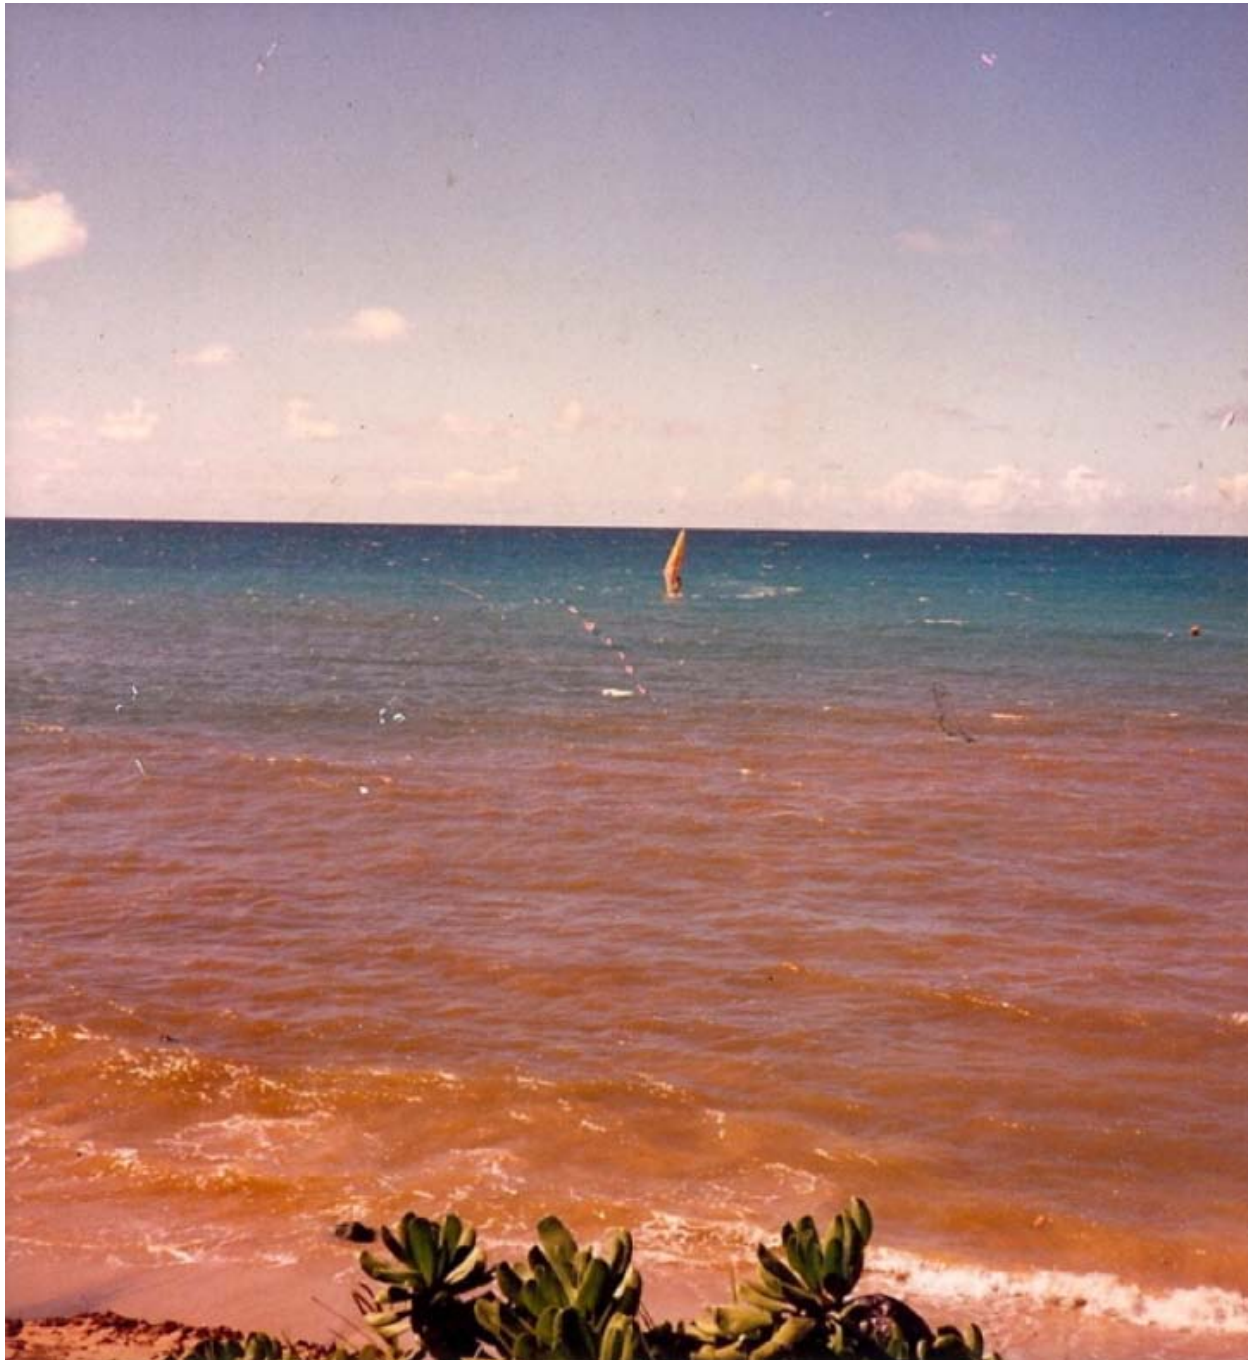
Figure 1-13 1986 - Nearshore turbidity related to erosion of the clay bank

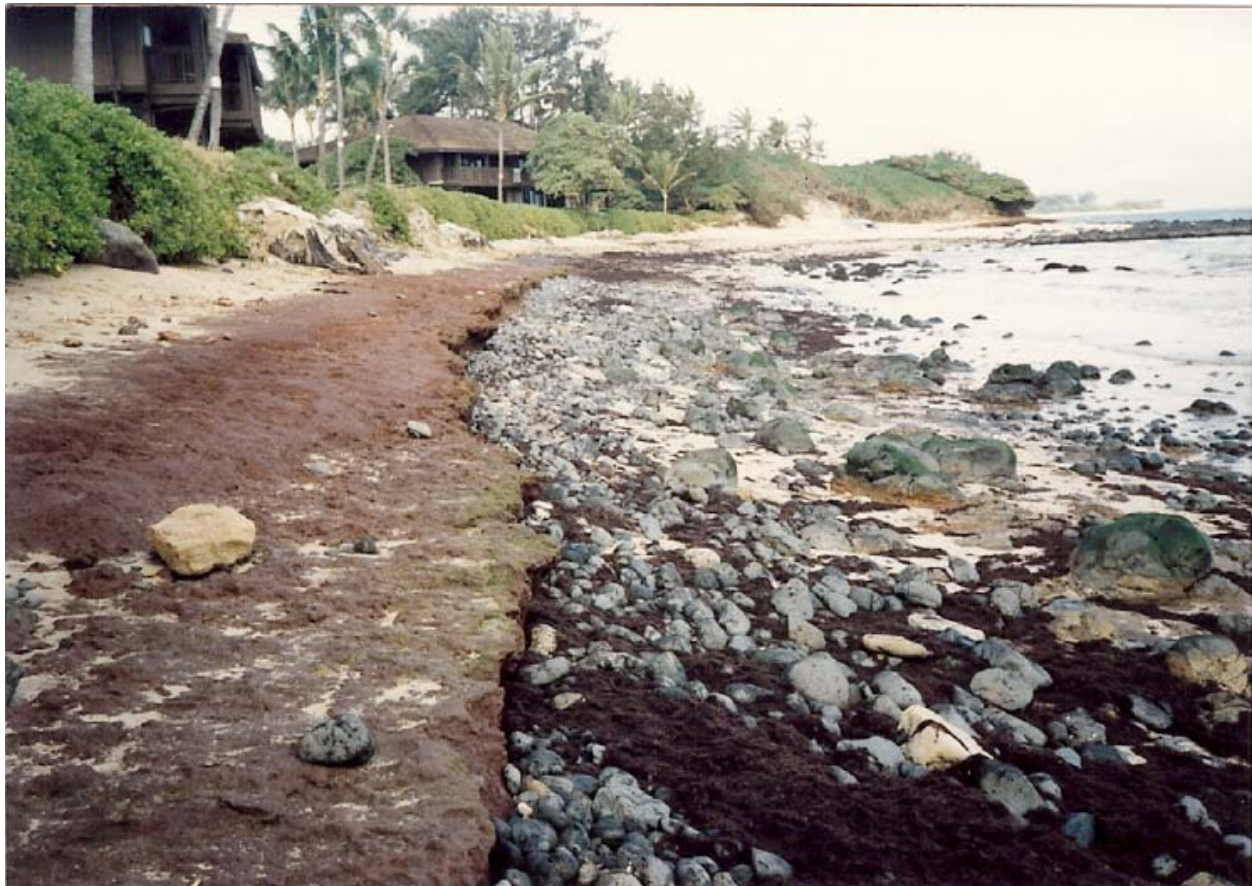
Figure 1-14 1989 - Wholesale loss of the beach in Sugar Cove

basalt boulders (Figure 1-14) that stretched along this entire length of the coastline. Though continued erosion into the clay bank resulted in ongoing loss of land and release of fine clay and silt sized particles into the marine waters, it did not result in a sand beach reforming at a more mauka location. The end result was complete loss of the sandy nearshore and sand beach ecosystems, heavily impacted nearshore waters with ongoing turbidity issues resulting from the erosion of the clay bank, and the glaring absence of a sand beach for public access and public recreation.

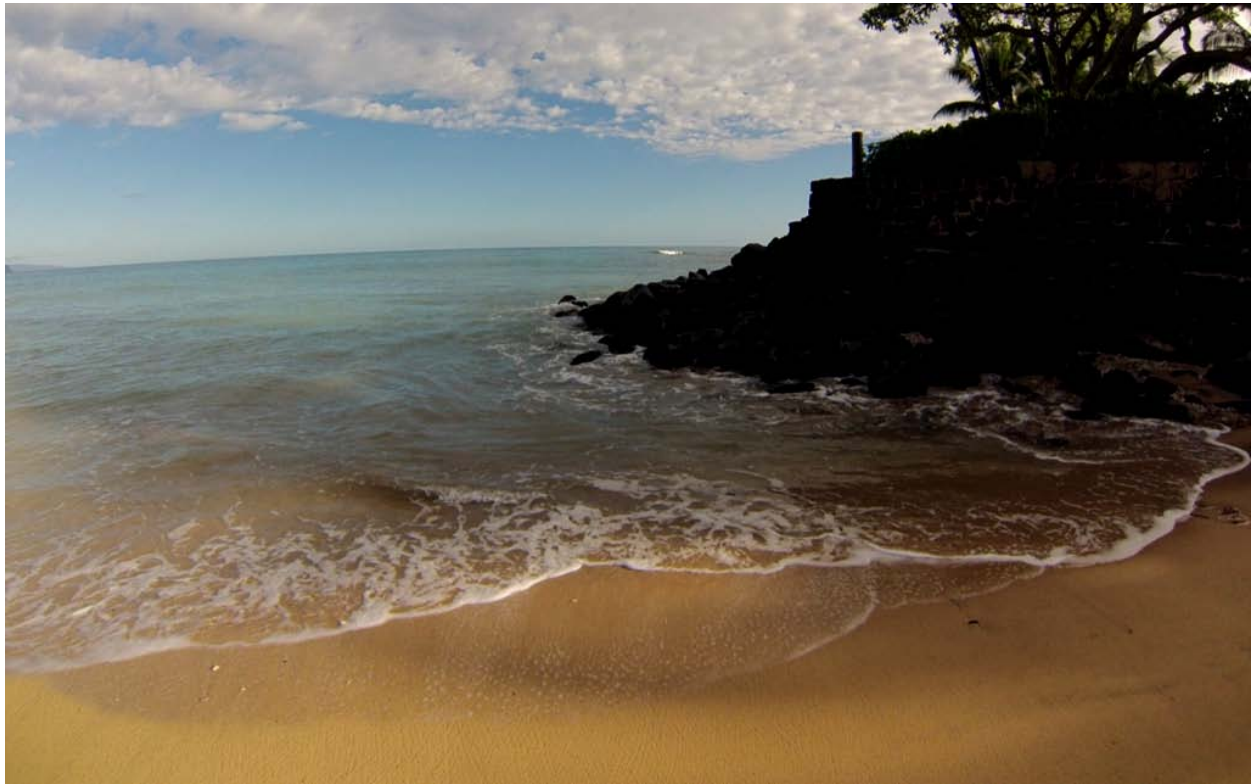
Figure 3-2 Seawall at eastern end of Sugar Cove beach

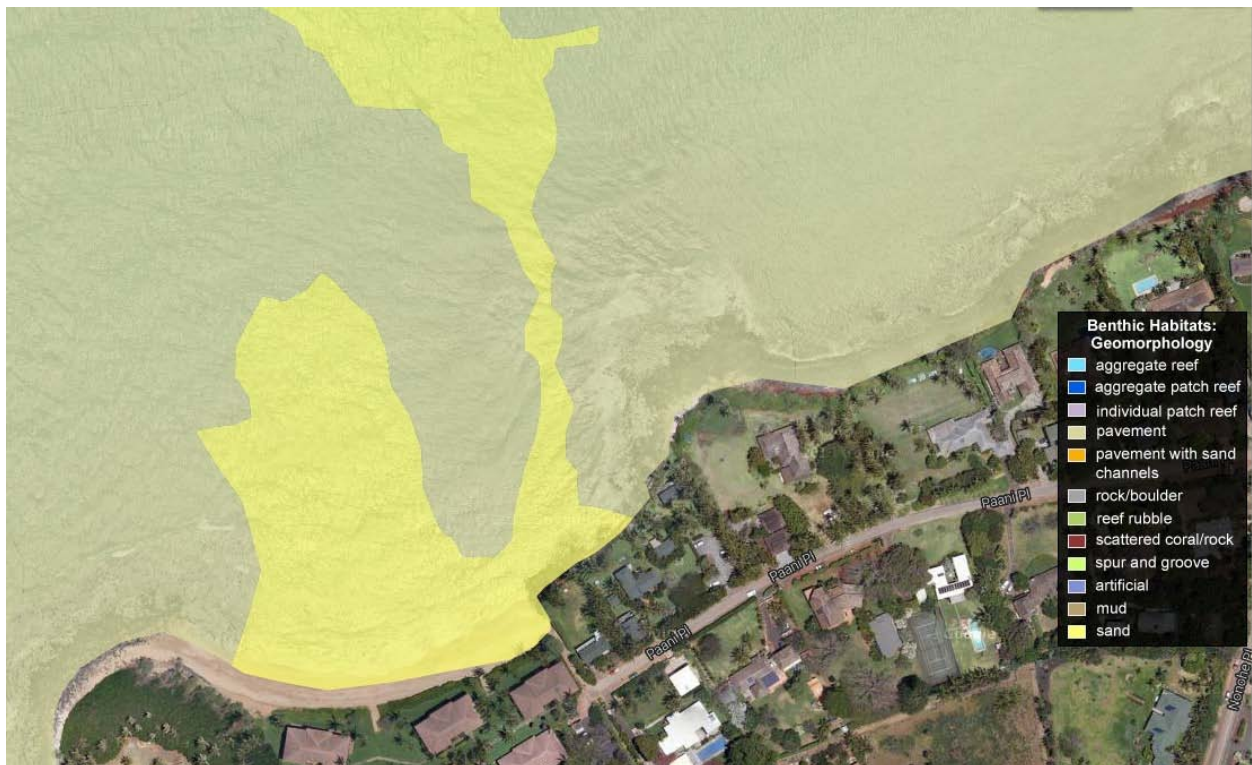
Figure 3-3 NOAA mapped benthic substrates for the area

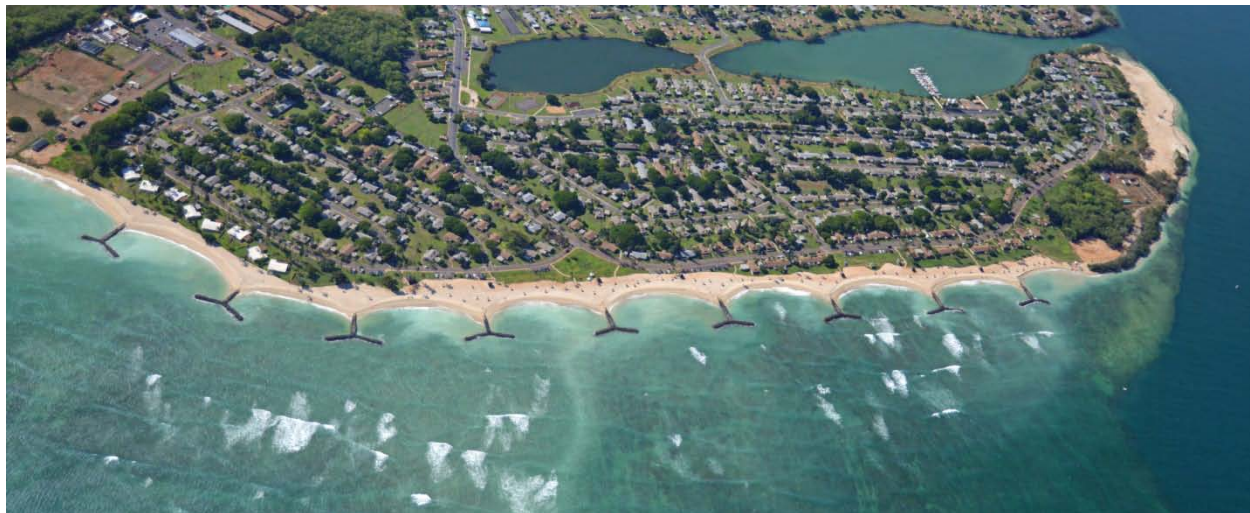
Figure 6-1 Iroquois Point beach restoration project with tuned T-Head groins

Engineered T-Head groins can be designed to both improve stability of the littoral cell and tune the shape of the subaerial beach. Tuned groins could be added to both the eastern and western headlands.

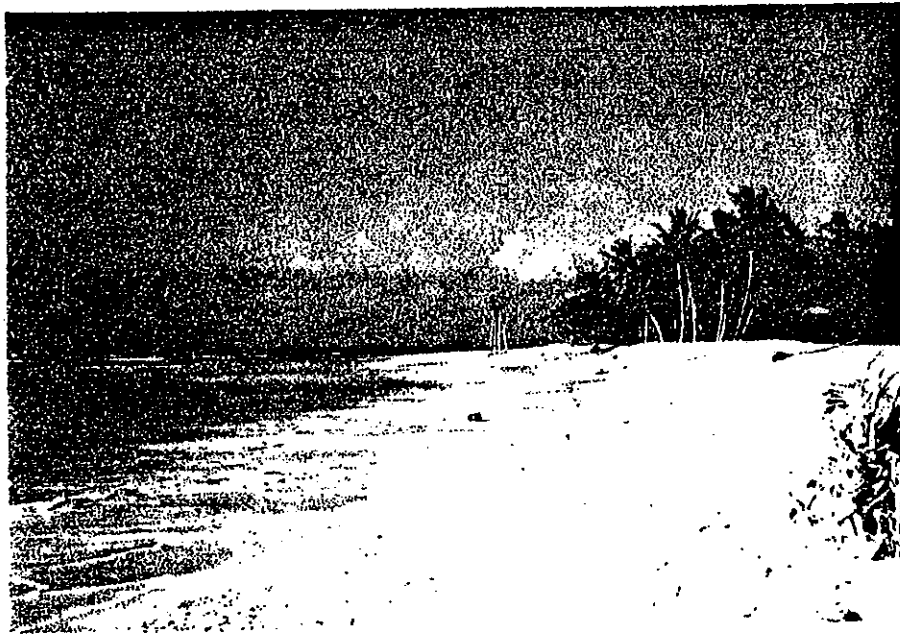
A. Industrial supply beach, Kapukaulua. Recession of beach has resulted in killing coconut trees. Breakers in left middle ground are on a westward extension of the same beach-rock ridge as shown in Plate 4-A.

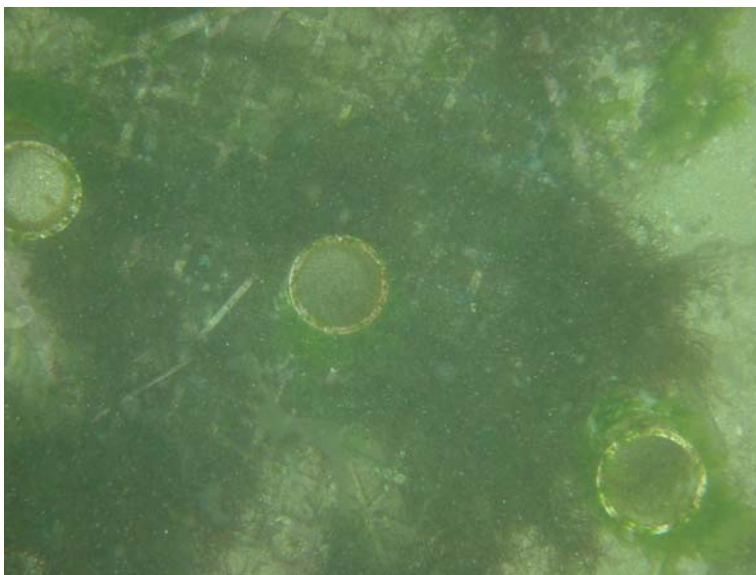
Figure 2: Sediment trap consisting of three 6" PVC pipe sections, capped on the bottom, supported by a garden tray.

Sediment traps were constructed using 6" sections of 2" diameter PVC pipe capped on one end and secured vertically through the holes in garden trays (Figure 2). Three pipe sections were used in each of three traps. The trays were held down with bricks, and zap-strapped to the hard bottom. Sediment suspended in the water column falls out and is collected in the pipes. The pipe sections were changed every month, providing that they were located, and sediment was dried and analyzed for mass, grain size, and carbonate fractionation.

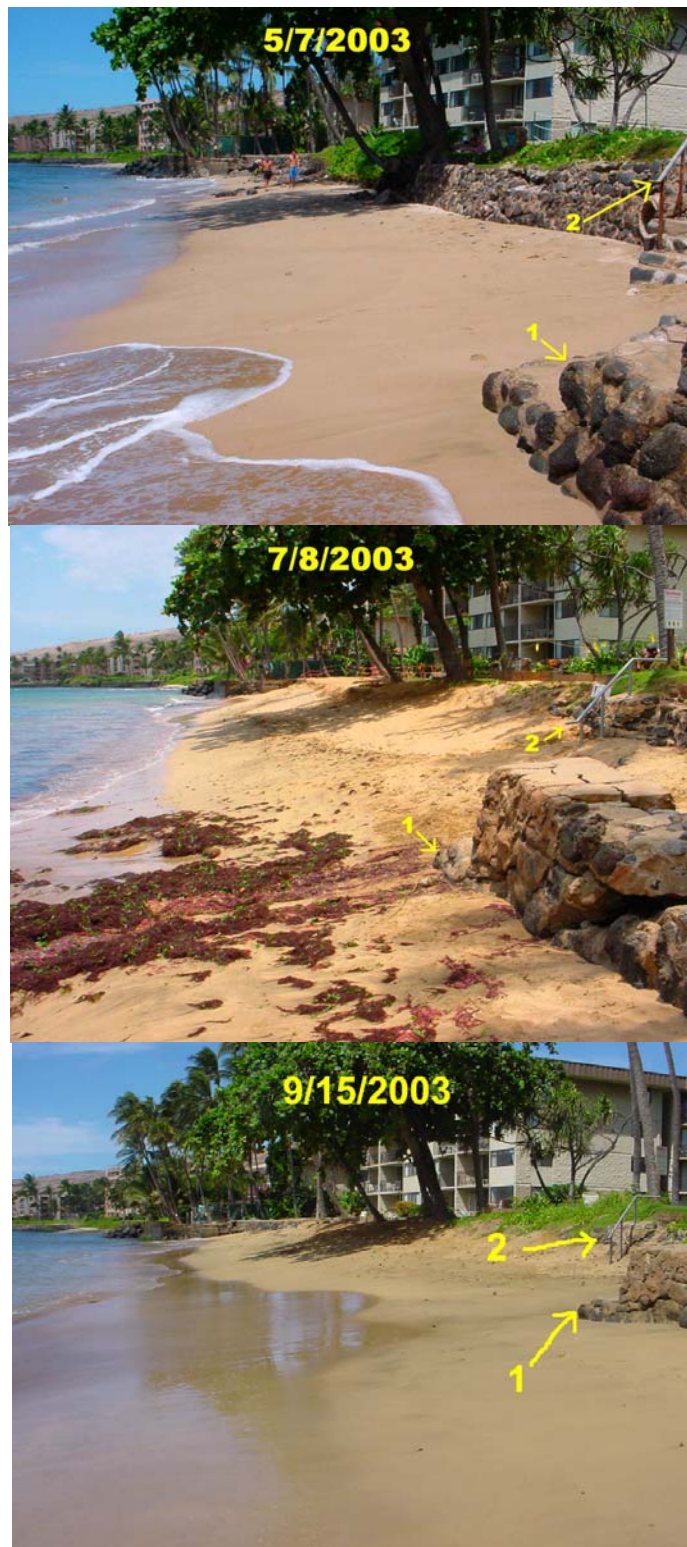
Figure 10: Looking southward over beach profiles 1, 2 and 3, before and after beach replenishment. Note the two points of reference.

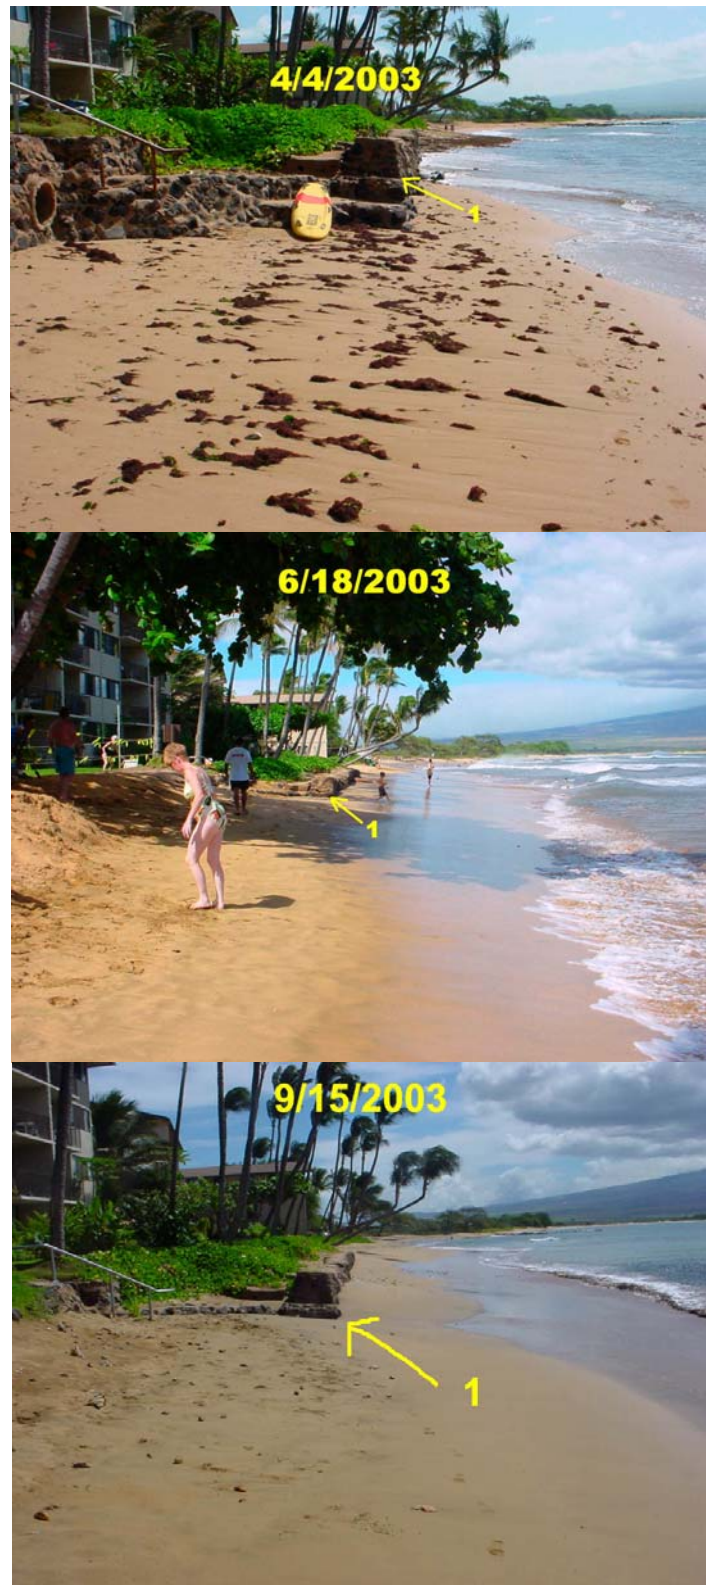
Figure 11: Looking northward over beach profiles 2 and 1, before and after beach replenishment. Note the point of reference.
